PIC16(L)F1934/1936/1937 Family Silicon Errata and Data Sheet Clarification

The PIC16(L)F1934/1936/1937 family devices that you have received conform functionally to the current Device Data Sheet (DS41364E), except for the anomalies described in this document.

Silicon Errata Issues

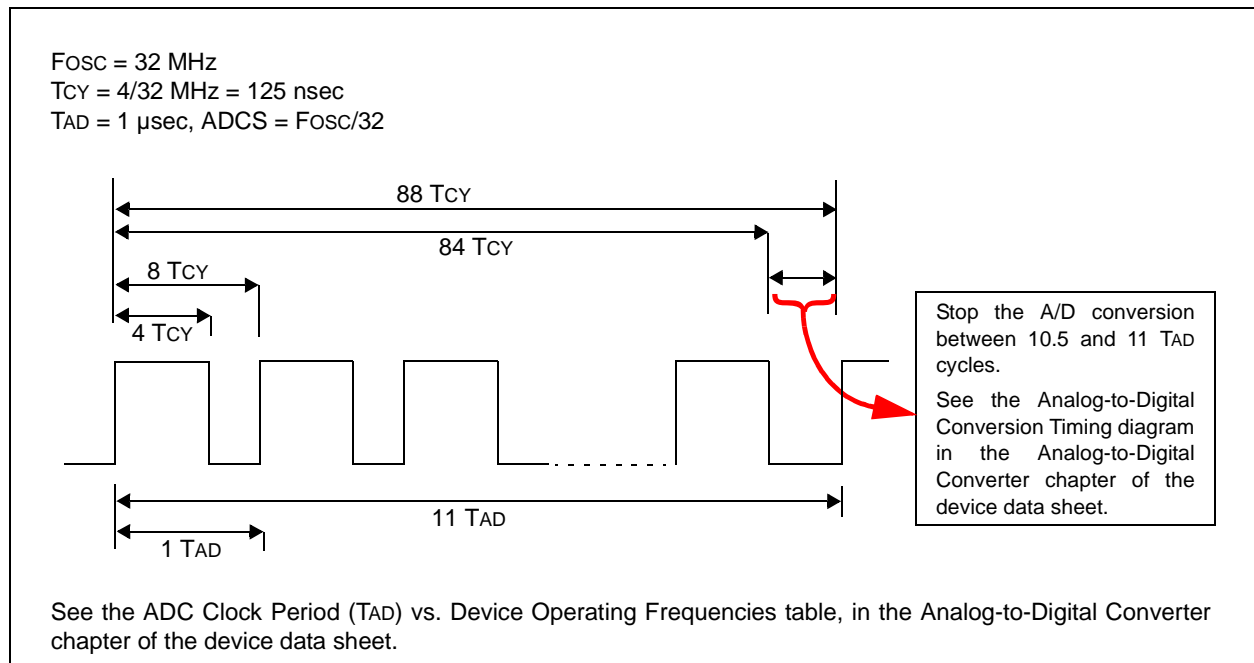
FIGURE 1: INSTRUCTION CYCLE DELAY CALCULATION EXAMPLE

In [Figure 1](#), 88 instruction cycles (TCY) will be required to complete the full conversion. Each TAD cycle consists of 8 TCY periods. A fixed delay is provided to stop the A/D conversion after 86 instruction cycles and terminate the conversion at the correct time as shown in the figure above.

Note: The exact delay time will depend on the TAD divisor (ADCS) selection. The Tcy counts shown in the timing diagram above apply to this example only. Refer to [Table 3](#) for the required delay counts for other configurations.

Method 3: This method is provided if the application cannot use Sleep mode and requires continuous operation at frequencies above 8 MHz. This method requires early termination of an ADC conversion. Provide a fixed time delay in software to stop the A-to-D conversion manually, after all 10 bits are converted, but before the conversion would complete automatically. The conversion is stopped by clearing the $\overline{GO/DONE}$ bit in software. The $\overline{GO/DONE}$ bit must be cleared during the last $\frac{1}{2}$ TAD cycle, before the conversion would have completed automatically. Refer to [Figure 1](#) for details.
